A System Safety Success: The Midcourse Space Experiment

Joyce A. McDevitt and Clayton A. Smith
Futron Corporation

SPIRIT III FAILURE

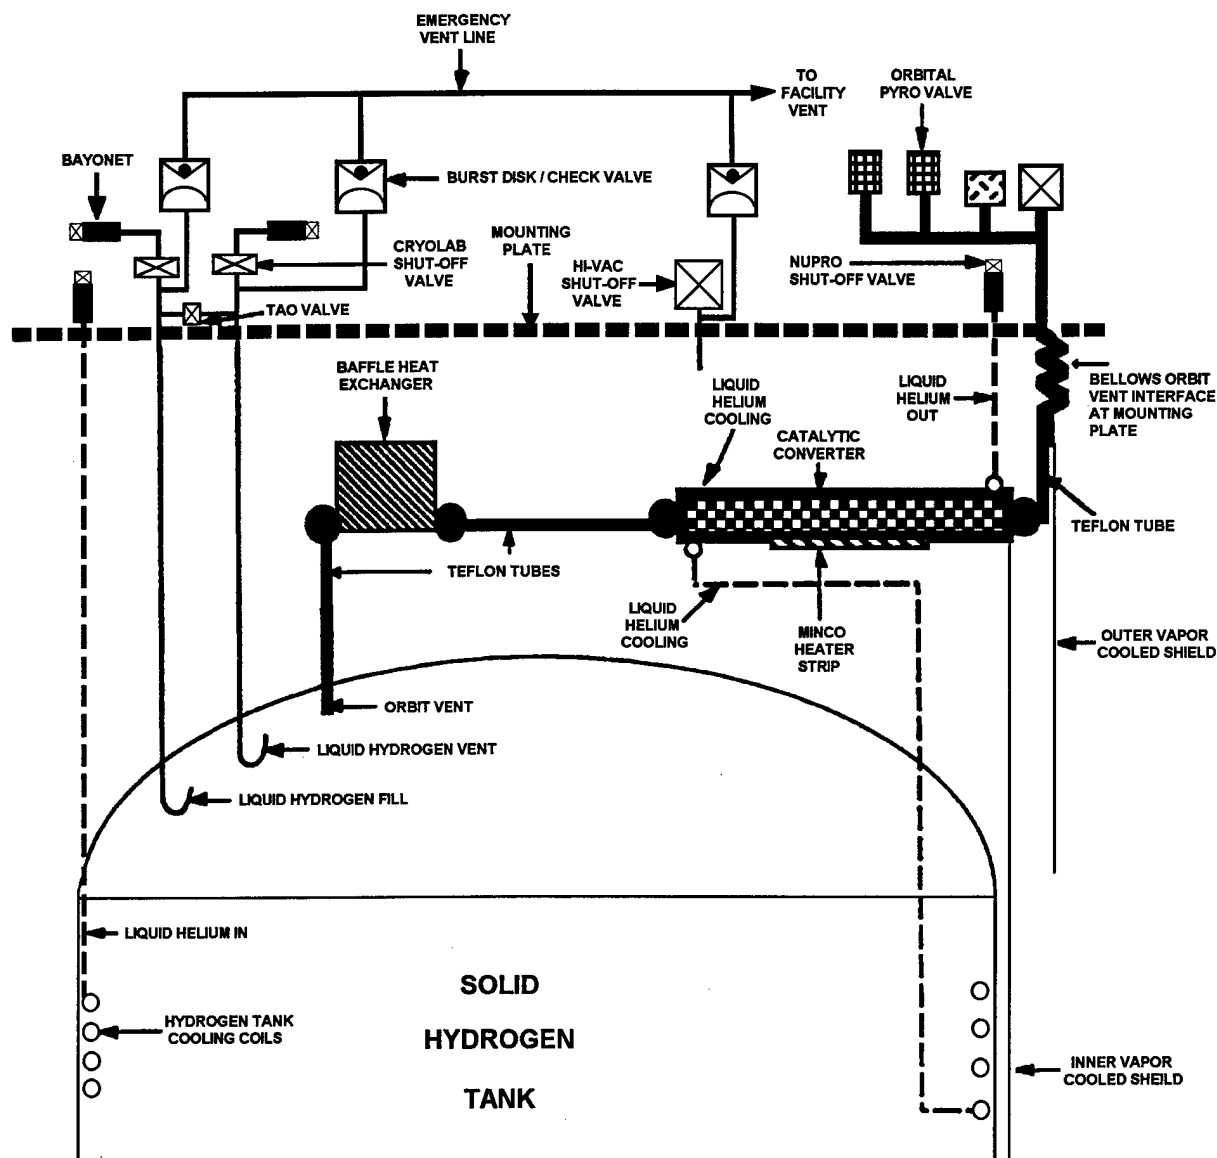
Figure 4. Cryostat Plumbing Schematic

Figure 4 shows the plumbing schematic for the SPIRIT III cryostat. This was the configuration of

the cryostat prior to the failure. There are five penetrations into the dewar; hydrogen fill and vent lines, helium cooling inlet and exit lines, and an orbit vent (only used on orbit). The hydrogen and helium lines are protected with a burst disk/check valve assembly and shared a common outlet, the emergency vent line. The orbit vent was capped (later changed) during ground processing with two pyro vent valves to be opened on orbit. The vacuum space between the dewar and outer shell is also protected with a burst disk/check valve in case the tank ruptured inside the outer vacuum shell. Inside the tank are the liquid helium cooling coils used to solidify the liquid hydrogen.

A formal failure analysis was conducted. During equipment breakdown and repair, a picture of the failure scenario emerged. A solid hydrogen plug had formed in the orbit vent line trapping hydrogen gas between the plug and the capped end. Concurrently (and independently), a small leak had developed in this line between the plug and the tank. The leak caused the pressure and temperature to rise in the vacuum space and also in the trapped portion of the orbit vent line.

Eventually the pressure rise in that portion of the line ruptured its weakest link, the catalytic converter.

The most plausible theory suggests there were two anomalies required to cause the failure; lines plugged with solid hydrogen and a leak. The first anomaly was the formation of solid hydrogen plugs in one of the two thermally isolated Teflon tubes in the orbit vent line. The formation of these hydrogen plugs in the orbit vent line was not recognized as a potential problem for a number of reasons:

The second anomaly was a leak in a Teflon tube that allowed a higher heat load to the internal cryostat plumbing. With the high heat loads, the warming solid hydrogen trapped within the orbit vent lines sublimed, building pressure until the components failed.

It is beyond the scope of this paper to detail all of the changes to the hardware and procedures. A failure investigation team from BMDO and a separate investigation team from USU/SDL and LMSC researched the design, materials, physics, failure modes, quality systems, and manufacturing techniques. The output of that process was a new configuration of the internal plumbing, specifically the addition of a burst disk check valve assembly on the orbit vent line. Another major consequence was that the "Gas Phase Top-Off" procedure was deleted to assure adequate ullage for hydrogen expansion.

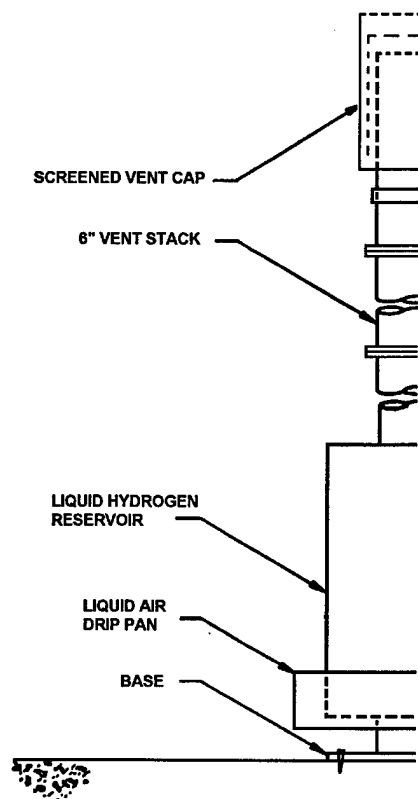
Figure 5. Emergency Vent Configuration

The vent system (see Figure 5) consists of a plumbing cluster external to the hydrogen tank, a 2-inch diameter vacuum-jacketed flexhose, and a vent stack outside the facility. The flexhose connects the plumbing cluster on the spacecraft to the vent stack by penetrating the wall of the building. The stack includes a 35-gallon liquid reservoir (to catch any liquid hydrogen) with a stack extending above the roof to safely vent the hydrogen. A catch basin was located at the base of the stack to contain any liquid air runoff on the outside. The stack is terminated with an atmospheric isolator and low ESD emission vent tip. A constant gaseous helium purge is supplied to inert the stack.

The only anomaly noted with the vent system was a small hydrogen leak at the main tank burst disk. Because the vacuum jacketing at this joint was less than other places, an o-ring in the joint froze allowing some hydrogen gas to leak into the facility. This leak, as measured with the portable hydrogen monitor, was not significant. The monitor indicated a hydrogen gas presence but would not provide a steady state reading or identify the exact leak location. Several other flex-

hose joints showed signs of icing, but no leaks could be detected.
